# Case Studies in Construction Failure

Forensic Civil Engineering Seminar 2016 (FoRCES), UTM,  
4-5 Oktober, Kuala Lumpur, Malaysia

# Case Studies

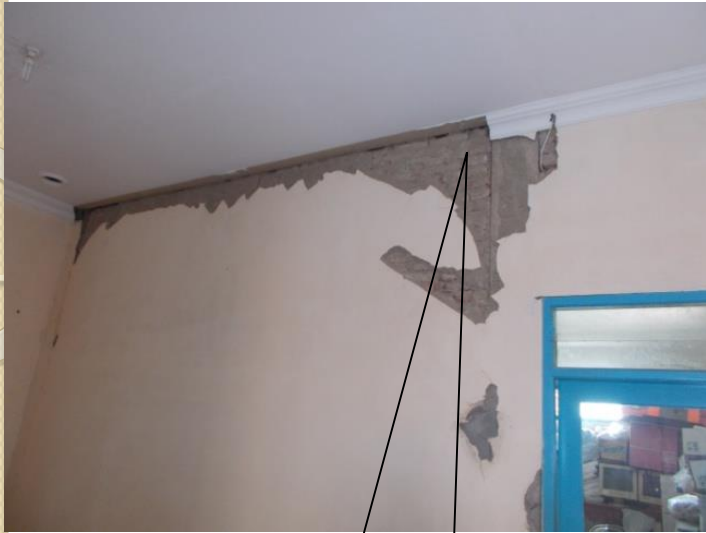
There are no connection

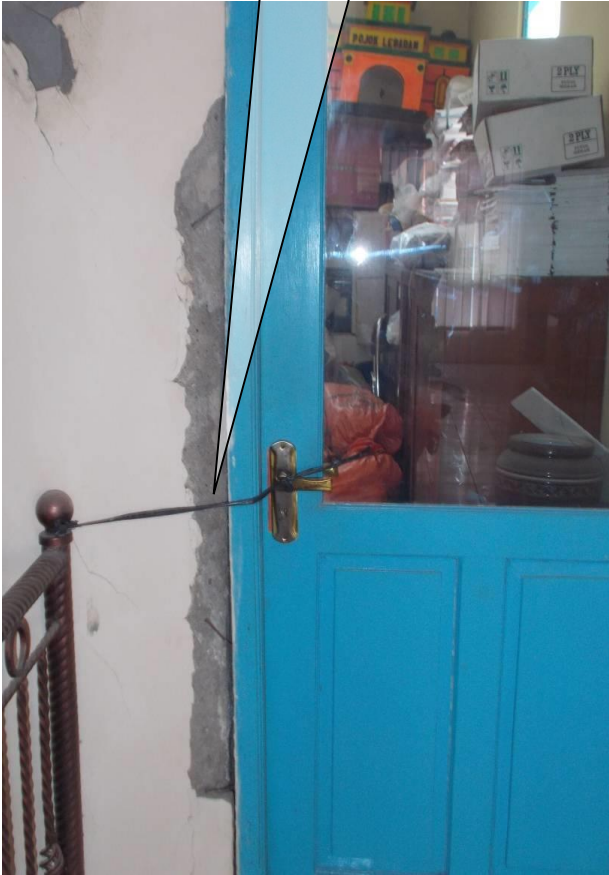
Under standard

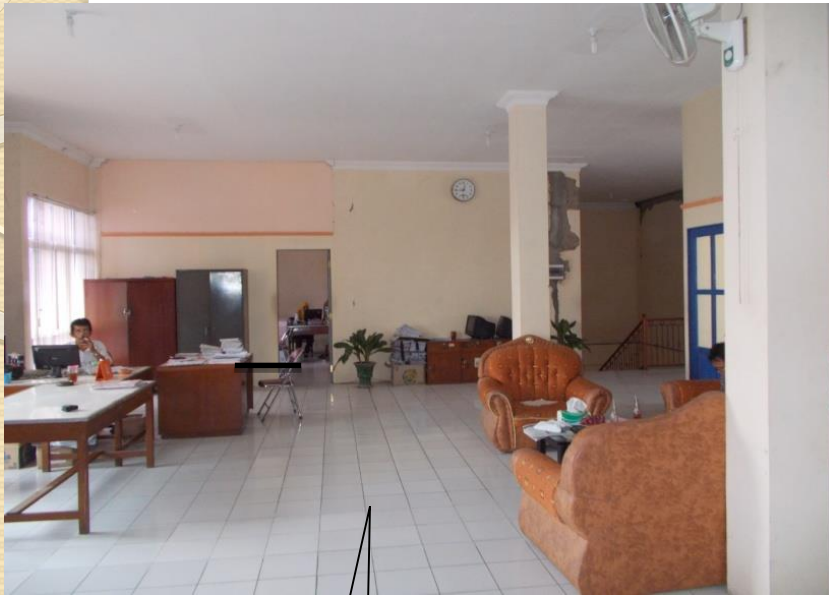
2<sup>nd</sup> floor  
vibrating

Average concrete  
strength 133  
kg/cm<sup>2</sup> (K-133)

Thickness of plate  
90 mm (core drill  
test)

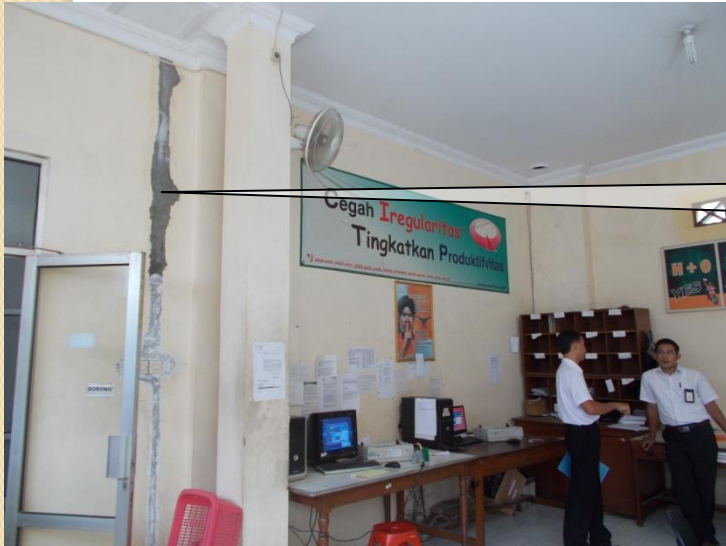
Wide crack on wall at 1st floor

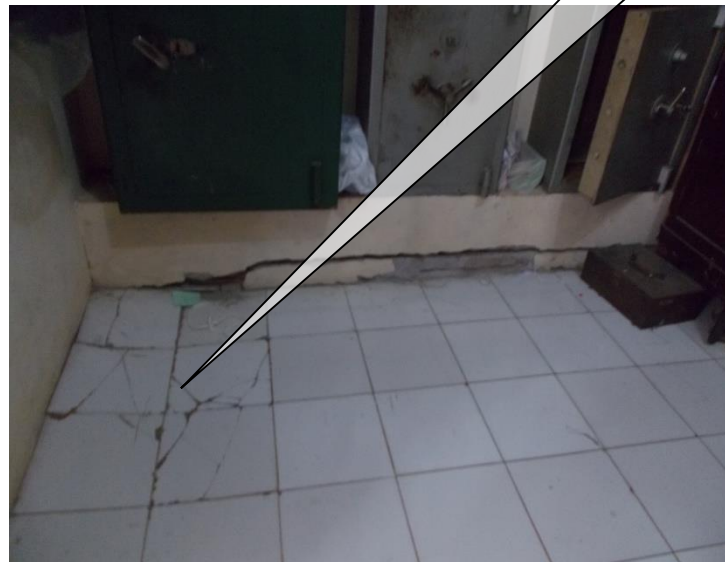
Deflection at 1st floor, Indication of foundation settlement

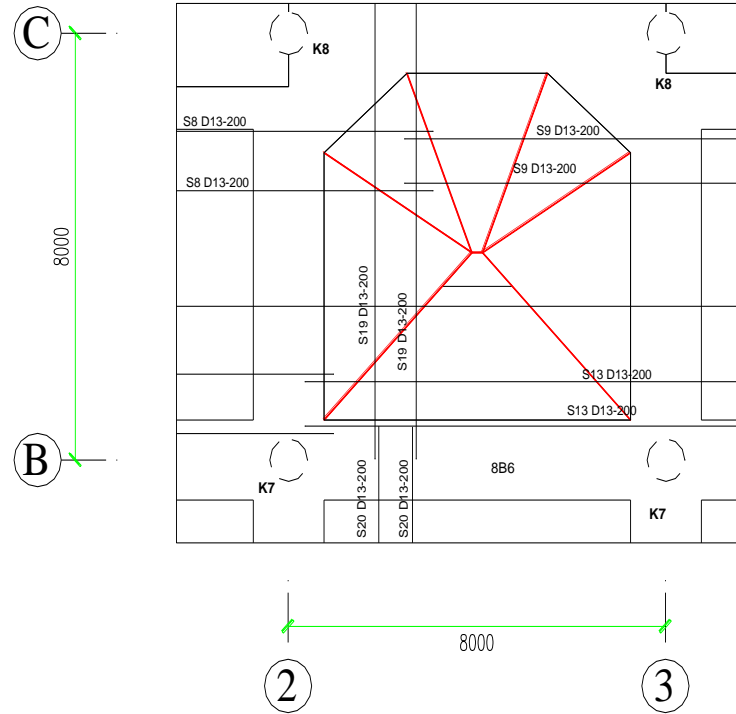
# Detail Evaluation of Plate Design

— = Garis leleh

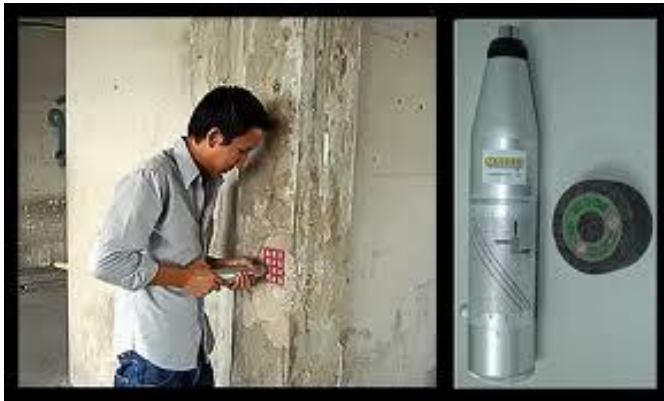
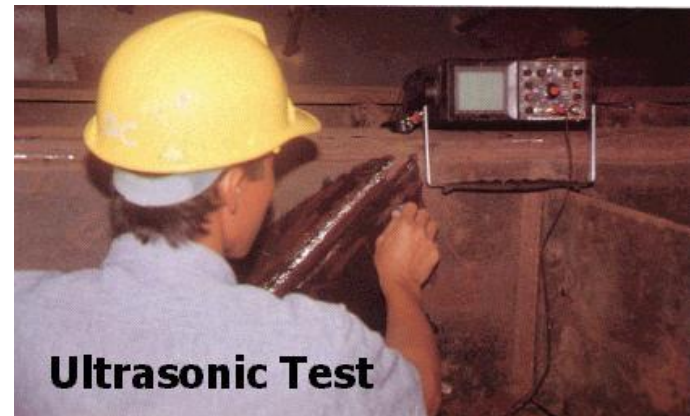
## Non-destructive test

Concrete compressive strength characteristics for plate on 6<sup>th</sup> floor = KI77 or  $f'_c = 14,7$  MPa.

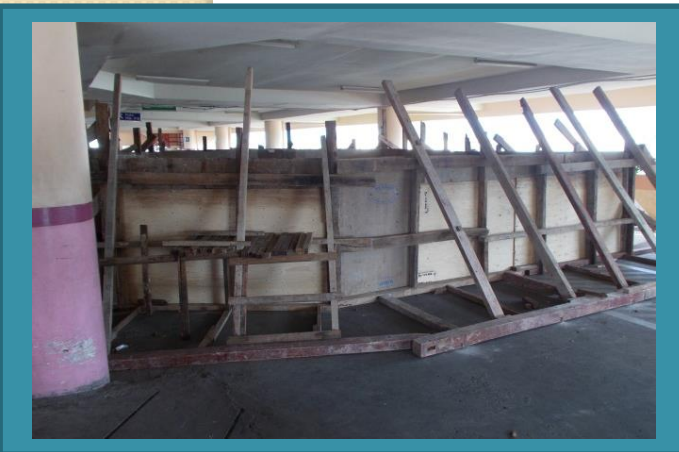
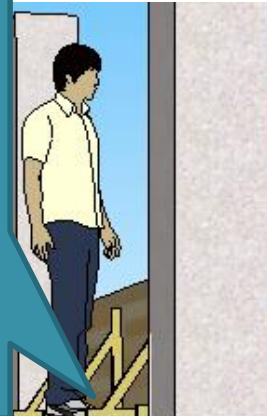
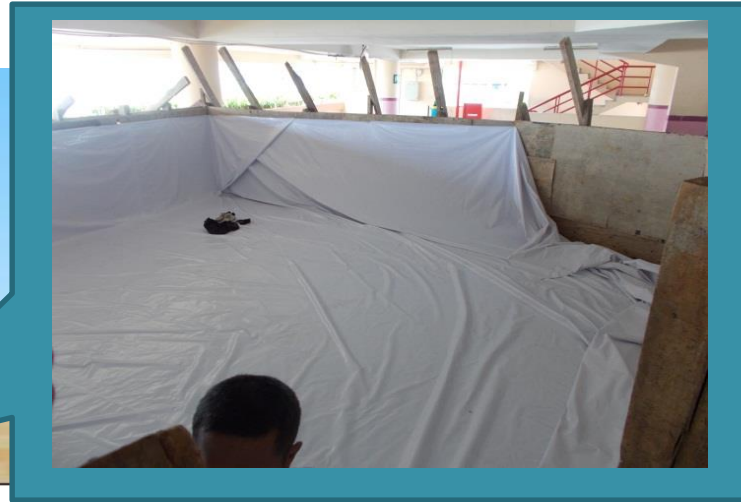
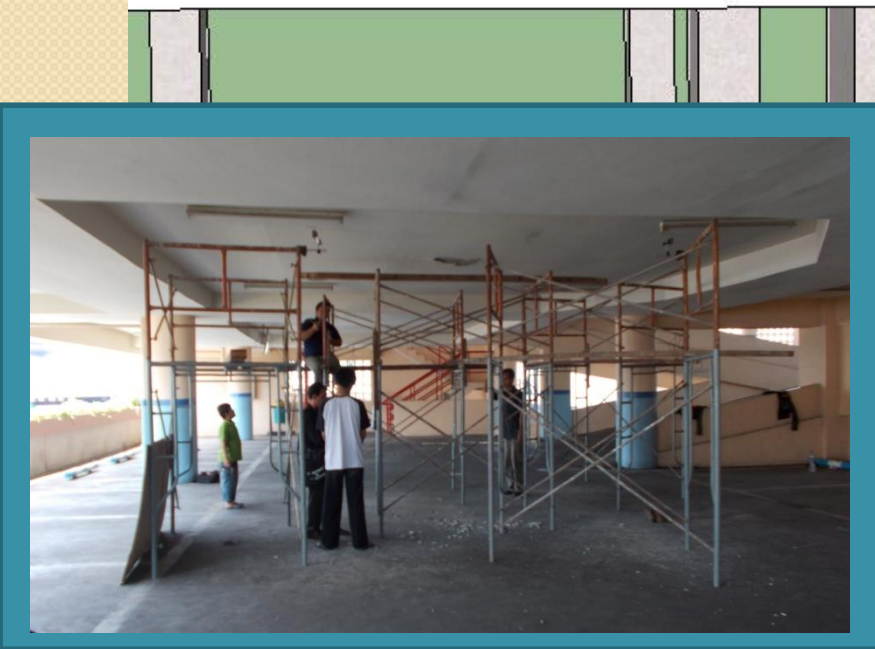
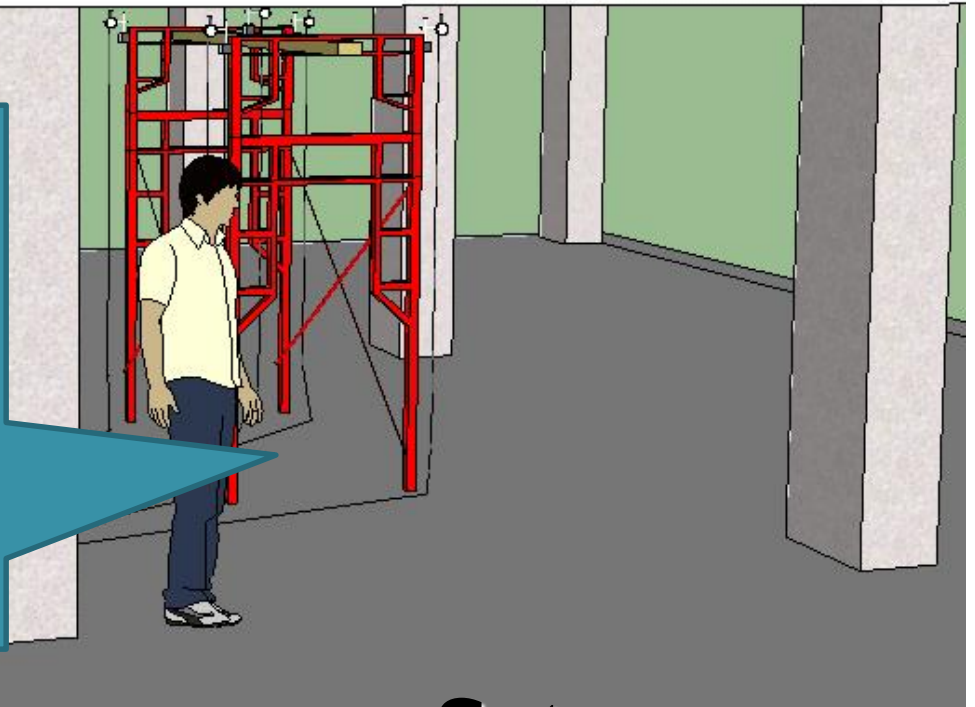
**Set-up**

# Loading test (Semi Destructive Test )

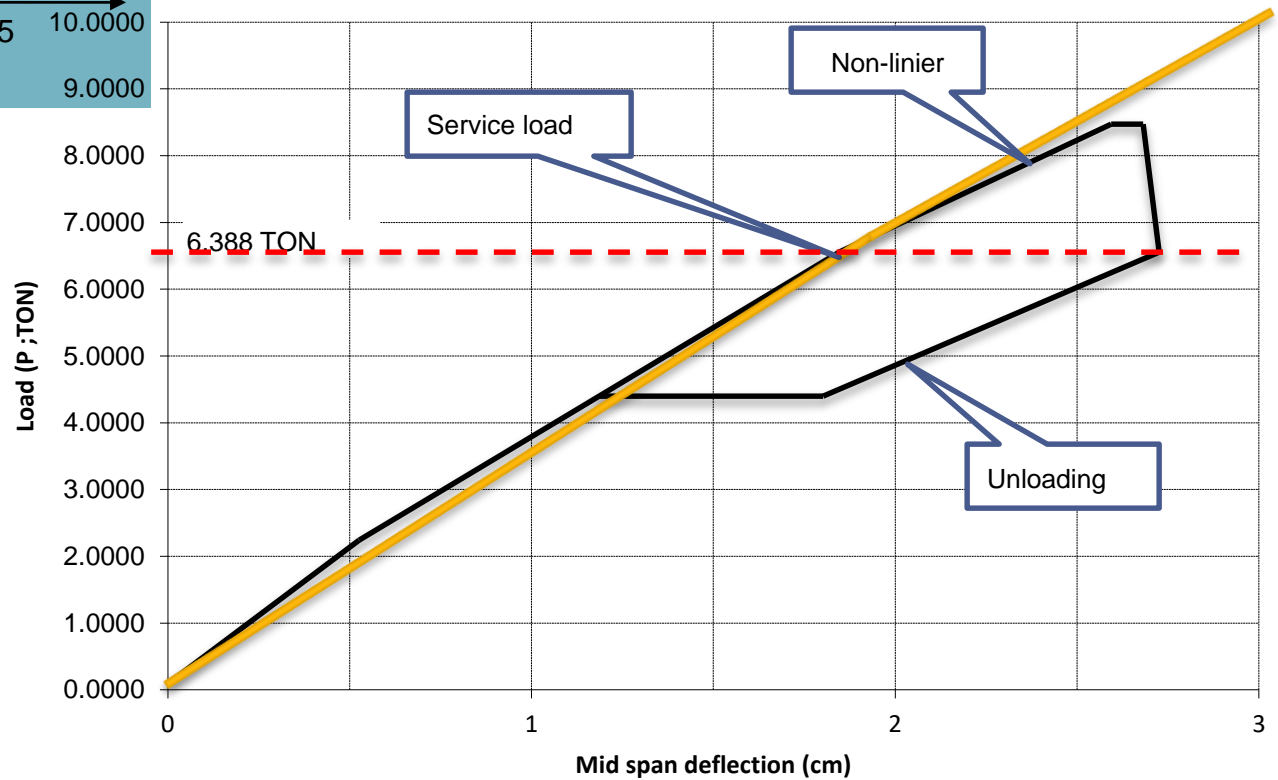
## Curve of Load vs Mid span deflection

Properties	Analysis	Loading Test
Service load (ton)	6,393	6,338
Live load (kg/m <sup>2</sup> )	150,42	195

Main Conclusion :

- Plate on 6<sup>th</sup> floor (As 2-3 and As B-C) underestimate for live load, so the plate to reconstruction.
- Other plat must strengthening

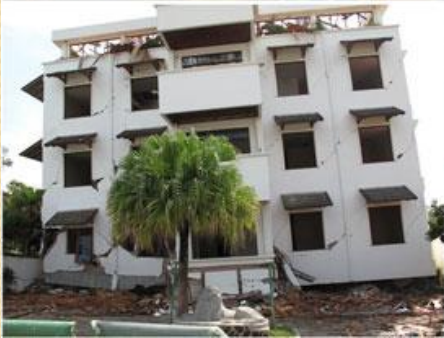
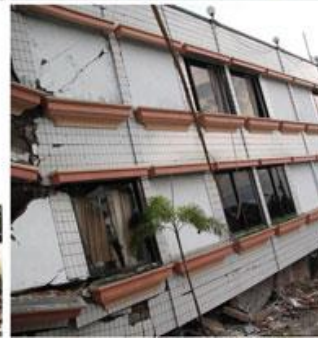
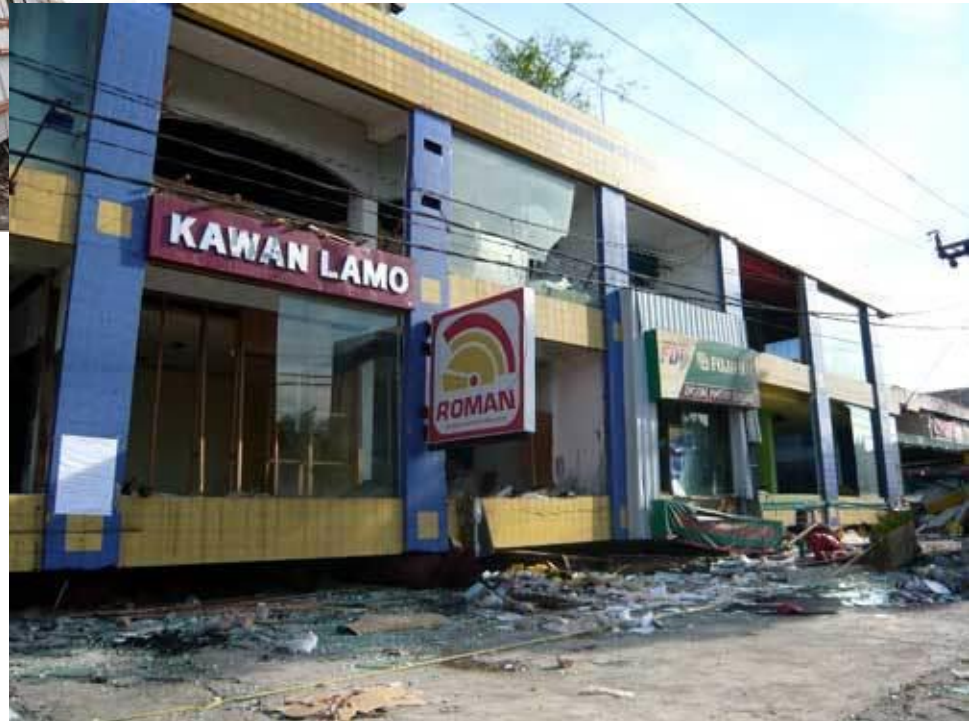
Padang Earthquake 2009

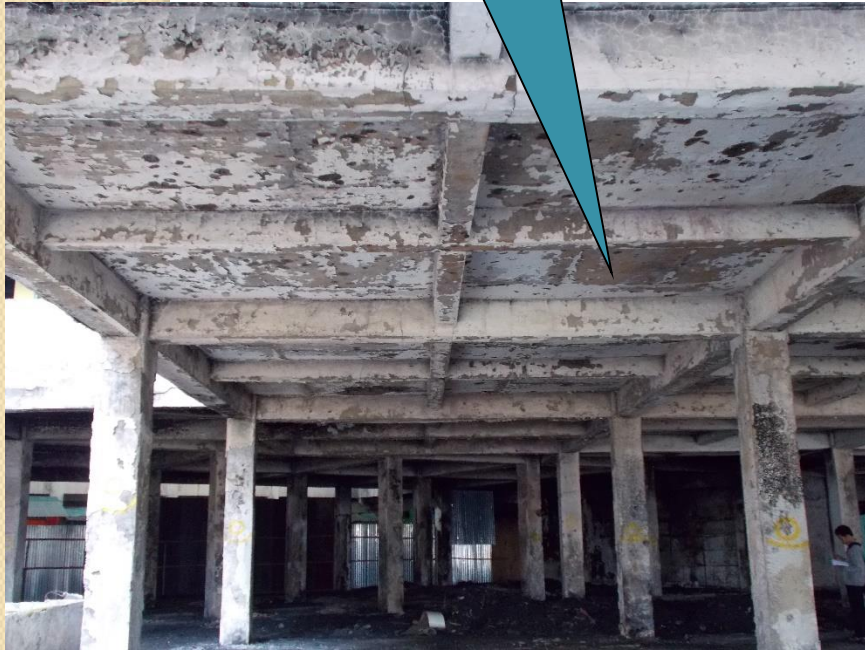
Large deflection  
of plates

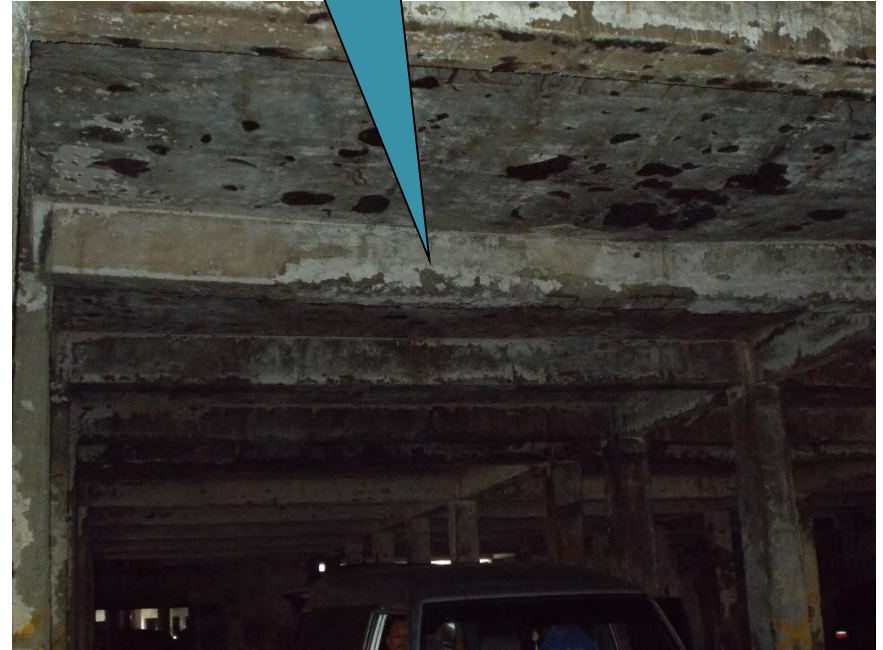
Large deflection  
of beams
