## Landslide on a Deeply Landfilled Slope: A Case Study of Tembalang, Indonesia

Rifqi Brilyant Arief<sup>a</sup>, Gatot Rusbintardjo<sup>a</sup>, Nur Izzi Md. Yusoff<sup>b\*</sup>

### Abstract

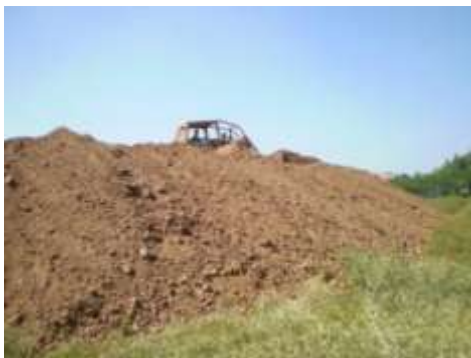
Figure 2 Landfill construction

The front of the building was sited at a higher elevation than the back, and most of the first floor was situated in the filled area. The soil materials used for landfill were taken from the land in front of the building, as shown in Figure 2. The slope of the embankment was set to follow the fall of soils in order to make it stable. As a consequence, the ground was not properly compacted and in some parts had a horizontal to vertical ratio of 1:4.

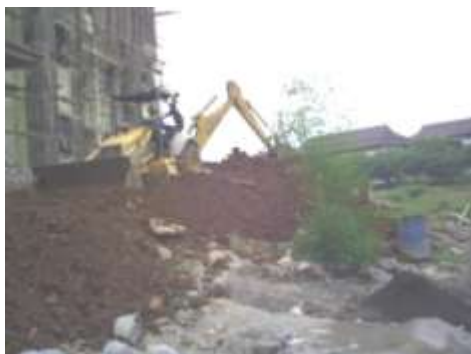
Figure 3 Landfill construction after the start of building construction

The sequence of the construction was as follows. First, foundation piles were driven into the ground and a pile cap was constructed. Foundation beams were added the ground was then levelled. The first floor of the building was constructed first and after this was completed, the surface of the ground floor was further levelled until it reached the required elevation. The landfill work was still on-going when the retaining wall and septic tank construction started, as shown in the Figure 3.

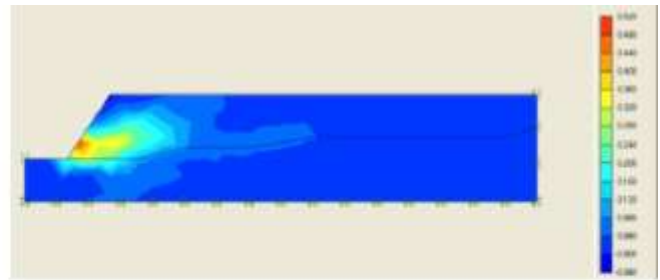
Figure 7 Strain in the slope when soil is dry <sup>1</sup>

As long as the weather remains dry, the slope is safe and no sliding occurs. Maximum strain in the fill was only 0.52%, as shown in Figure 7. The FOS was calculated to be 1.29.
